XE166M Derivatives

Real Time Signal Controller

Edition 30.01.2009

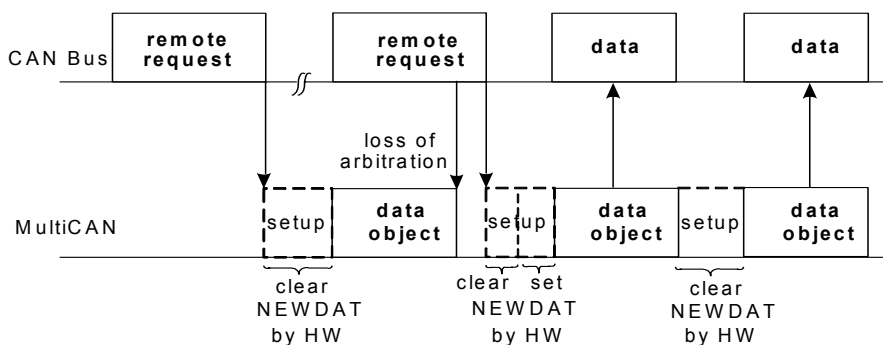
Figure 1 Loss of Arbitration

When the appropriate message object (data frame) triggered by the first remote frame wins the arbitration, it will be sent out and `NEWDAT` is not reset. This leads to an additional data frame, that will be sent by this message object (clearing `NEWDAT`).

There will, however, not be more data frames than there are corresponding remote requests.
