## Stellaris<sup>®</sup> LM3S1811 RevB1 Errata

This document contains known errata at the time of publication for the Stellaris<sup>®</sup> LM3S1811 microcontroller. The table below summarizes the errata and lists the affected revisions. See the data sheet for more details.

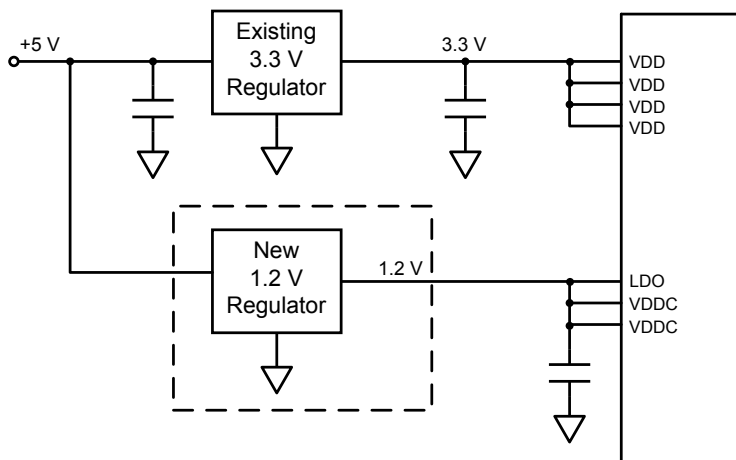
**Figure 2. Configuration of External Regulator**

Incorrect power sequencing during power up can disrupt operation and potentially cause device failure.

$V_{DDC}$  must be applied approximately 50  $\mu$ s before  $V_{DD}$ . Normally  $V_{DDC}$  is controlled by the part's internal LDO voltage regulator. The workaround requires the addition of an external regulator (see Figure 2) to ensure that  $V_{DDC}$  sequencing requirements are met (see Figure 3). Recommended regulators include FAN1112SX (SOT223) and FAN2558S12X (SOT23-5).

This fix mitigates the on-chip power issue, but does not solve it completely. During development, the Flash memory should also be reprogrammed (using LMflash or another programming tool) at least once a week.
