## Stellaris<sup>®</sup> LM3S3Z26 RevB1 Errata

This document contains known errata at the time of publication for the Stellaris<sup>®</sup> LM3S3Z26 microcontroller. The table below summarizes the errata and lists the affected revisions. See the data sheet for more details.

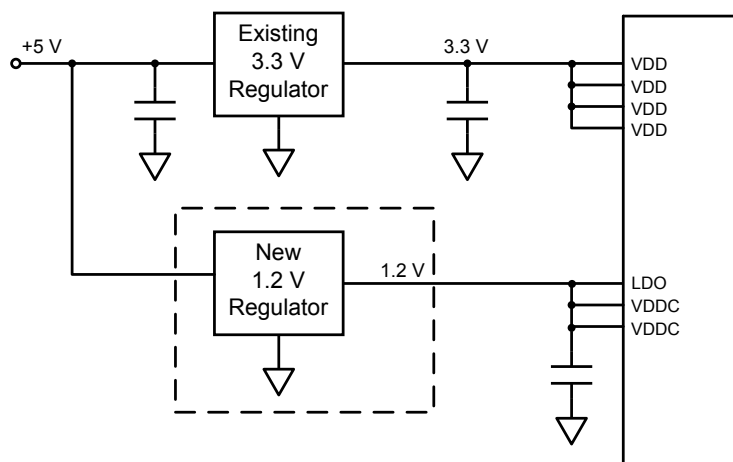
**Figure 2. Configuration of External Regulator**

### 10.1 Power-on event may disrupt operation

Incorrect power sequencing during power up can disrupt operation and potentially cause device failure.

$V_{DDC}$  must be applied approximately 50  $\mu$ s before  $V_{DD}$ . Normally  $V_{DDC}$  is controlled by the part's internal LDO voltage regulator. The workaround requires the addition of an external regulator (see Figure 2) to ensure that  $V_{DDC}$  sequencing requirements are met (see Figure 3). Recommended regulators include FAN1112SX (SOT223) and FAN2558S12X (SOT23-5).

This fix mitigates the on-chip power issue, but does not solve it completely. During development, the Flash memory should also be reprogrammed (using LMflash or another programming tool) at least once a week.
