Stellaris[®] LM3S9L97 RevB1 Errata

This document contains known errata at the time of publication for the Stellaris[®] LM3S9L97 microcontroller. The table below summarizes the errata and lists the affected revisions. See the data sheet for more details.

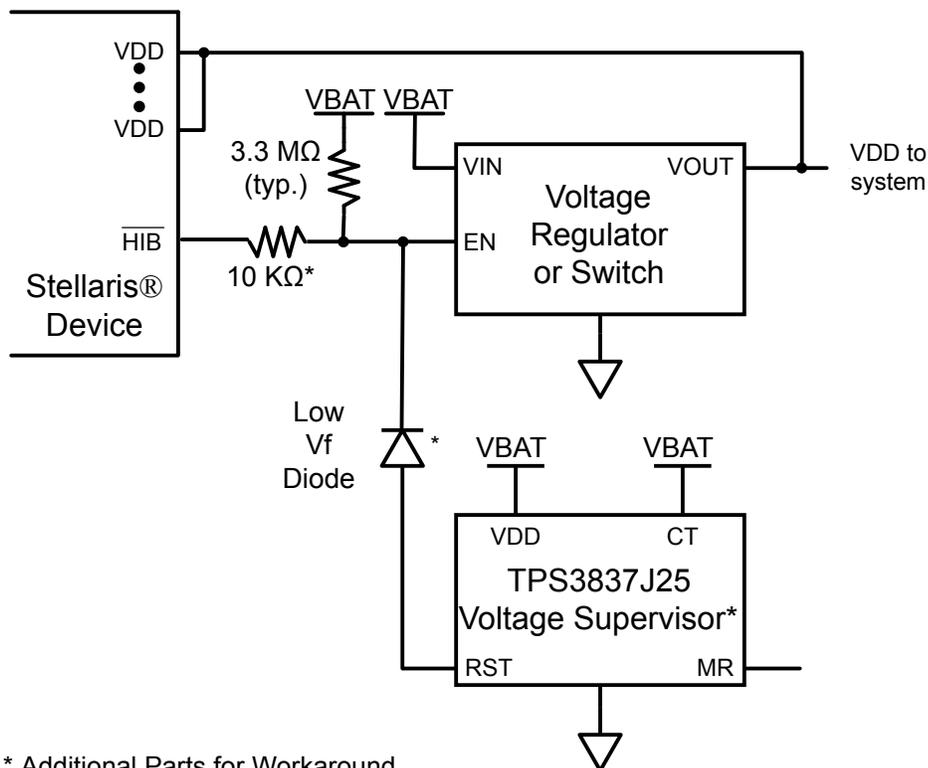
Figure 1. Workaround Circuit to Ensure Initial Power Up

Description:

If V_{DD} is not powered when voltage is first applied to V_{BAT} , the state of the Hibernation module is indeterminate and the \overline{HIB} signal may be asserted. In this indeterminate state, a lock condition can occur in which the Hibernation module waits for a power-on-reset, but that reset cannot occur until the module deasserts \overline{HIB} . This issue is related to the errata "Hibernation module may have higher current draw than specified in data sheet under certain conditions" on page 5.

The workaround implementation depends on the system-level power supply configuration. For systems that use a battery as the primary power source, an external voltage supervisor (TPS383J25DBV or similar) circuit can be added to force the V_{DD} power supply to start when the battery voltage is first applied (see Figure 1). The voltage supervisor requires only 220 nA and generates a 200-ms positive pulse to turn on the V_{DD} regulator and activate the microcontroller's internal POR circuit.

* Additional Parts for Workaround

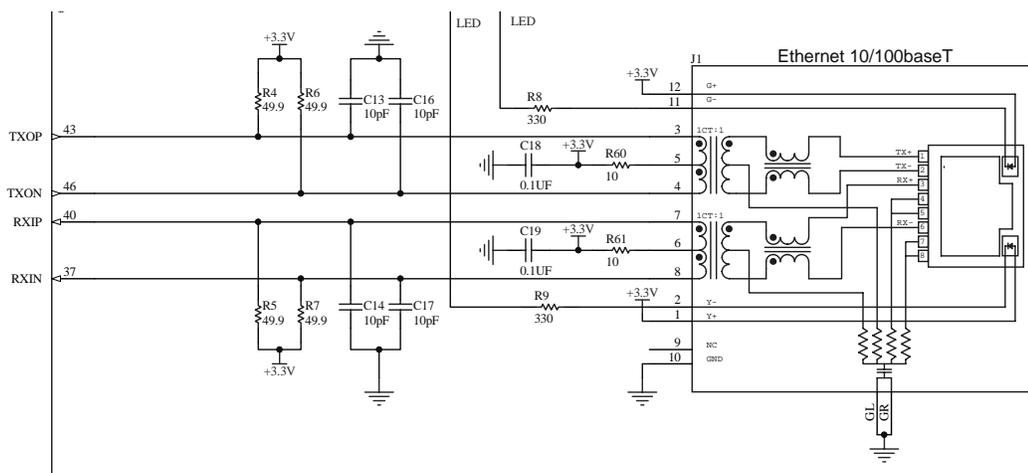
Figure 2. Recommended Center-Tap Connections

The microcontroller experiences some packet loss with Ethernet cables longer than 50 meters in normal operating conditions.

1. Add 10 Ω resistor to the center-tap of the transformer as shown in the figure. These resistors should be replaced by a direct connection for silicon that has this item fixed.
2. Continue using the recommended circuit, but limit cable lengths to 50 meters.

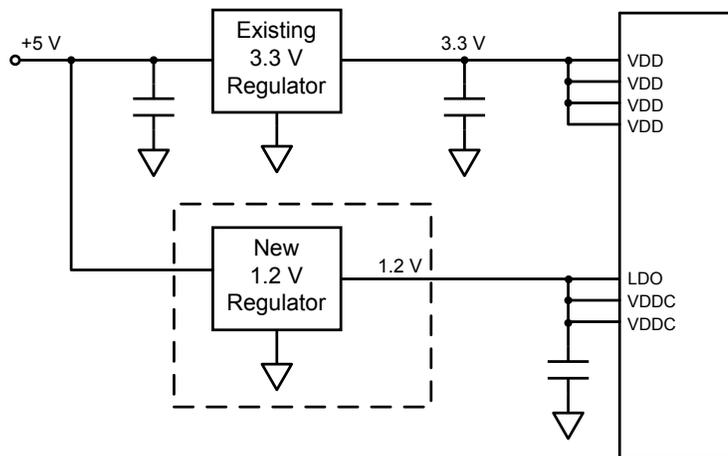
Figure 3. Configuration of External Regulator

Incorrect power sequencing during power up can disrupt operation and potentially cause device failure.

V_{DDC} must be applied approximately 50 μs before V_{DD} . Normally V_{DDC} is controlled by the part's internal LDO voltage regulator. The workaround requires the addition of an external regulator (see Figure 3) to ensure that V_{DDC} sequencing requirements are met (see Figure 4). Recommended regulators include FAN1112SX (SOT223) and FAN2558S12X (SOT23-5).

This fix mitigates the on-chip power issue, but does not solve it completely. During development, the Flash memory should also be reprogrammed (using LMflash or another programming tool) at least once a week.
